BITUMINOUS SURFACE REMOVAL - BUTT JOINT

CONTRACT NO. 70028
• (15,18-20)RS-2 & (15-22)RS-2
•• COLES & CUMBERLAND

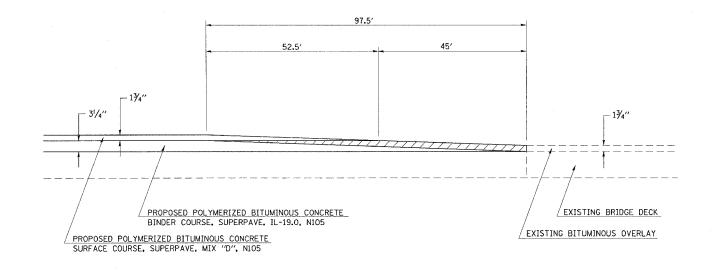
## DETAIL OF BUTT JOINT AT STRUCTURES 015-0003, 015-0004, 015-0005 & 015-0006 AT IL. RTE. 16 & ICRR (EASTERN)

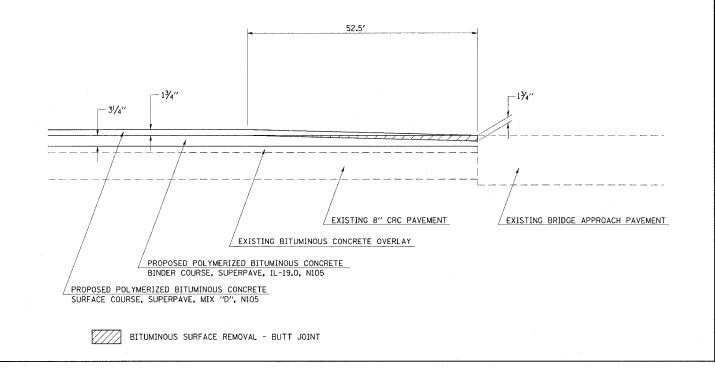
## DETAIL OF BUTT JOINT AT STRUCTURES 015-0051, 015-0052, 015-0053, 015-0054, 015-0001 & 015-0002

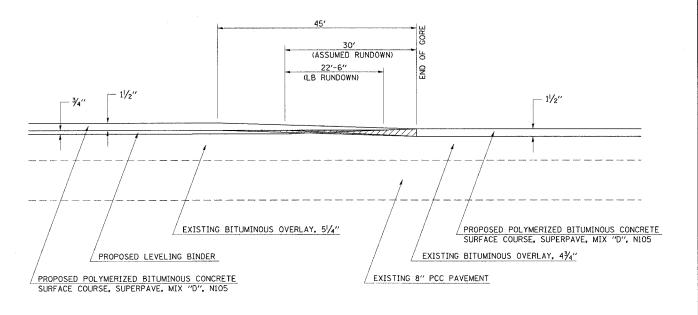
## DETAIL OF BUTT JOINT AT RAMPS "B" & "D" I-57 / U.S. RTE. 45 AT NEOGA

BITUMINOUS SURFACE REMOVAL - BUTT JOINT

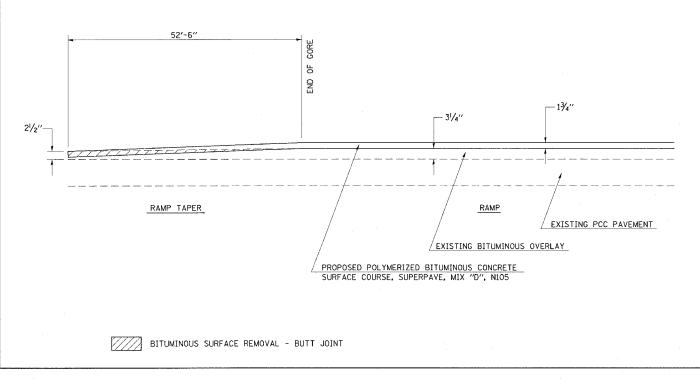
## DETAIL OF BUTT JOINTS AT RAMPS A, B, C, D, E, F, G & H I-57 / IL. RTE. 16 INTERCHANGE
